# The Bridge on the River Kraai

This article follows on the article “Cry the beloved railway” that appeared in the May 2013 edition of *Civil Engineering* (pages 40–45), and which was Highly Commended at the 2013 PiCA Awards in the category Non-Professional Writer of the Year.

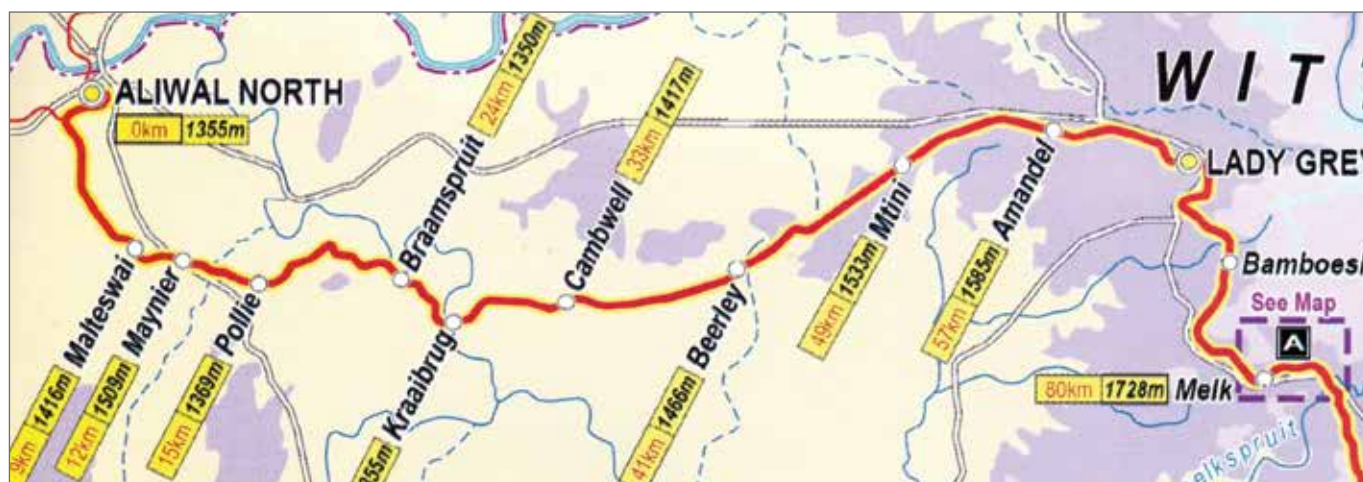
Figure 1: The Kraal River railway crossing at Kraaibrug lies between Aliwal North and Lady Grey, while the first six of the famous reverses (see *Civil Engineering* May 2013) are in the rectangle marked on the right (Map by Bruno Martin, published in *Tracks Across the Veld* by Boonzaaier, 2008, used with permission)

Between Aliwal North and Lady Grey the railway line traversed relatively easy terrain, the most significant obstacle being the crossing of the Kraai River about 17 miles (27 km) from Aliwal North (see Figure 1). During construction, a temporary bridge (#1) was erected at a position which cannot

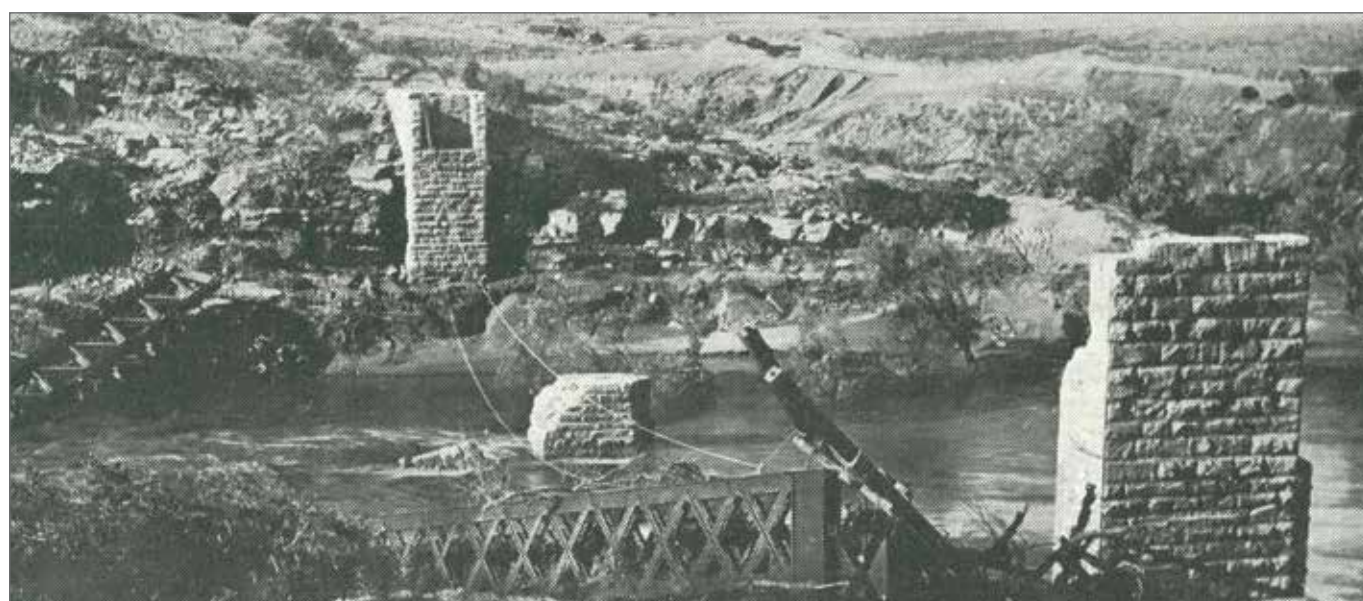
Figure 2: Kraal River Bridge (#2), shortly after being washed away on 23 March 1925, viewed from slightly downstream on the true left bank (*SA Railways and Harbours Magazine*, July 1925)

For twenty years the Kraai River Bridge served the branch line without problems. However, during March 1925 the catchment area of the Kraai River (roughly centred on Barkly East), and other parts of South Africa, experienced unusually heavy and continuous rains, resulting in historic flood flows. Situated at the downstream end of the river close to its confluence with the Orange River, the bridge was washed away on March 23, as shown in Figure 2. Evidently the river normally carried about

Contemporary observations at the bridge site indicate a flow depth of 76 ft, an almost unbelievable rise in water surface elevation (WSEL) of about 66 ft. Figure 2, a photograph clearly taken from the true left bank just downstream of the crossing, confirms the great depth of flow. All four Brown trusses were toppled downstream. Abutment geometry confirms that the structure was indeed a deck truss bridge (trusses below railbed). Unusually, the central bridge pier remained somewhat intact, probably founded on solid rock, but the superstructure took a significant part of the top masonry (perhaps half the pier) with it. Overtopped (by 5 ft), these Brown trusses would have acted quite efficiently as debris traps – trees float near the surface and

just below. Hinge supports on the centre span would likely not have been able to resist the high lateral forces induced by the flow on this particular type of truss with its trapped debris, and so the superstructure naturally folded horizontally at the centre towards downstream. Remnants of some of the original pier foundations are visible today, directly below the current bridge deck, as shown in Figure 10.

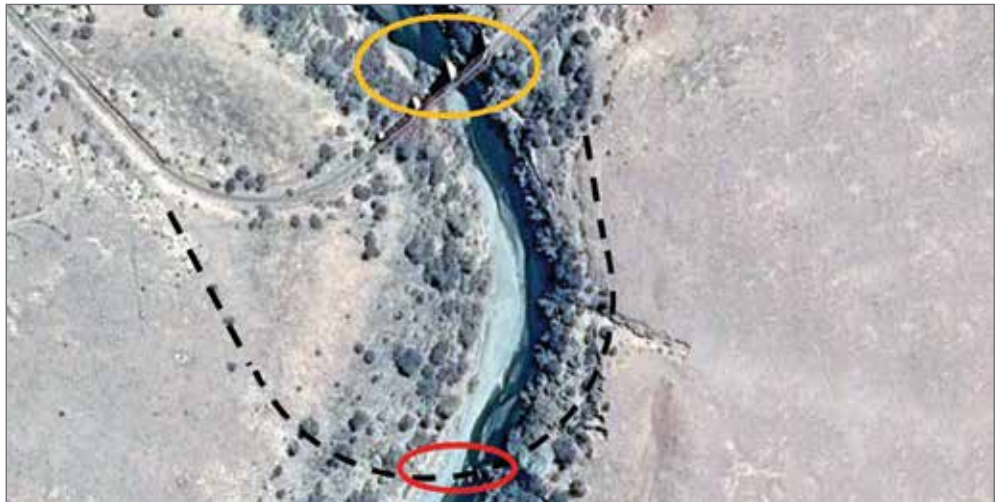
Figure 4: The permanent bridge position is marked yellow, the temporary bridge site red, and the approximate position of the deviation by a dashed line (Google Earth, annotated Johannes Haarhoff)

to cross the river 275 m upstream of the wrecked bridge, as shown in Figure 4.

Men and materials were hurried to the site, but it was days before the floods subsided sufficiently to allow work to begin. It continued to rain, on and off, day after day, but eventually a 450 ft long temporary bridge was built at the position depicted

in Figure 4. Because it was built at a much lower level, it was subject to a higher risk of erosion, and the railway line had to be connected to the bridge at a steep gradient of 1:30 on both sides. Piers were constructed using open timber cribs, stacking railway sleepers in “bird-cage” fashion, perhaps anchored by filling with rock. Track ran from pier to pier to form

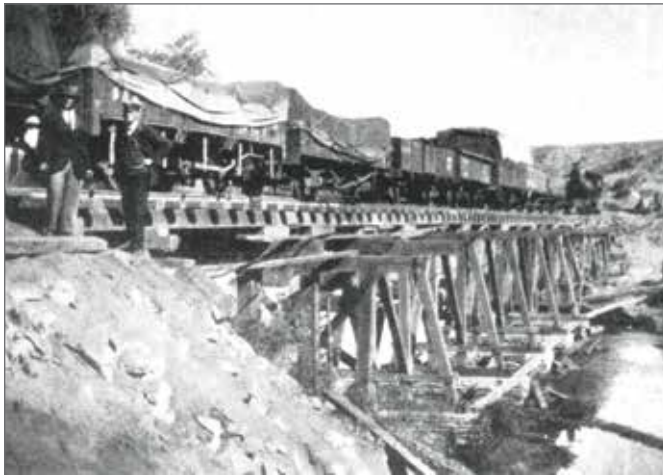
Figure 6: Temporary bridge #6, completed 25 June 1925 until washed away early March 1926 (SA Railways and Harbours Magazine, August 1926)

Adverse hydrology persisted. Less than a year later, at the beginning of March 1926, the temporary bridge (#6) was itself washed away. This is not surprising, as bridge #6 was built at a low level, clearly as a stop-gap measure, while the permanent bridge #7 was rebuilt. Reporting coldly on 5 March 1926, the *Barkly East Reporter* wrote, “As everyone anticipated, the first flood has washed away the temporary railway bridge at Braamspruit.” It is not clear when reconstruction of the second

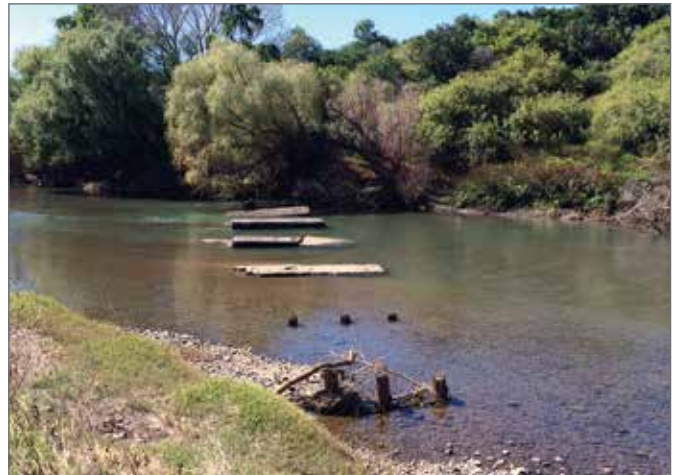
Figure 7: The site of temporary bridges #3 to #6 as it appears in 2014, from roughly the same viewpoint as Figure 5 (Photo Bertus Bekker 2014)

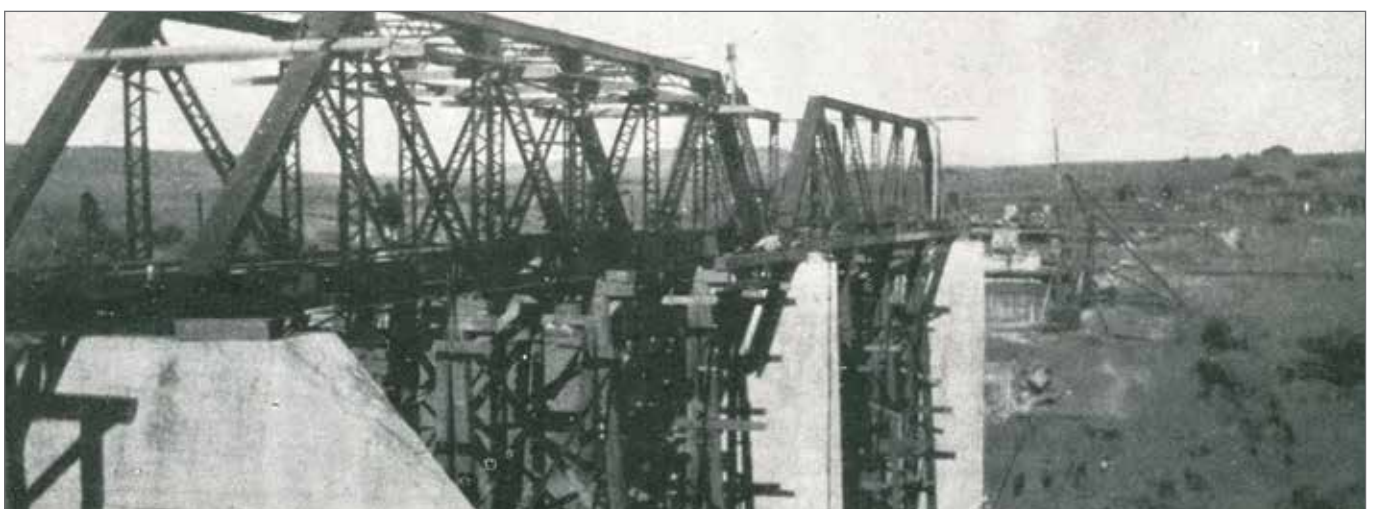
Figure 9: New permanent bridge shortly before completion, 8 June 1926; view towards Lady Grey (SA Railways and Harbours Magazine, August 1926)

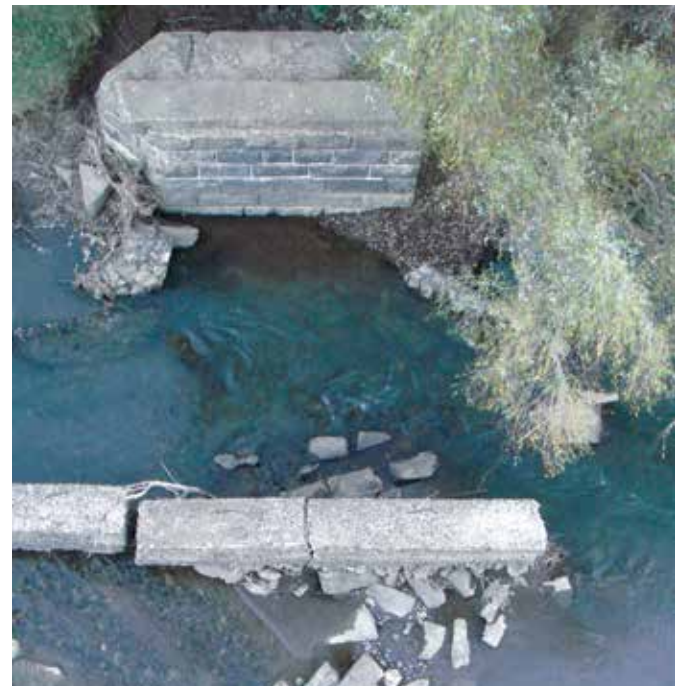
**Figure 10:** Some of the old pier foundation remnants of the first 1905 permanent bridge (#2) are still visible directly below the 1926 permanent bridge (#7) (Photo Bertus Bekker 2014)

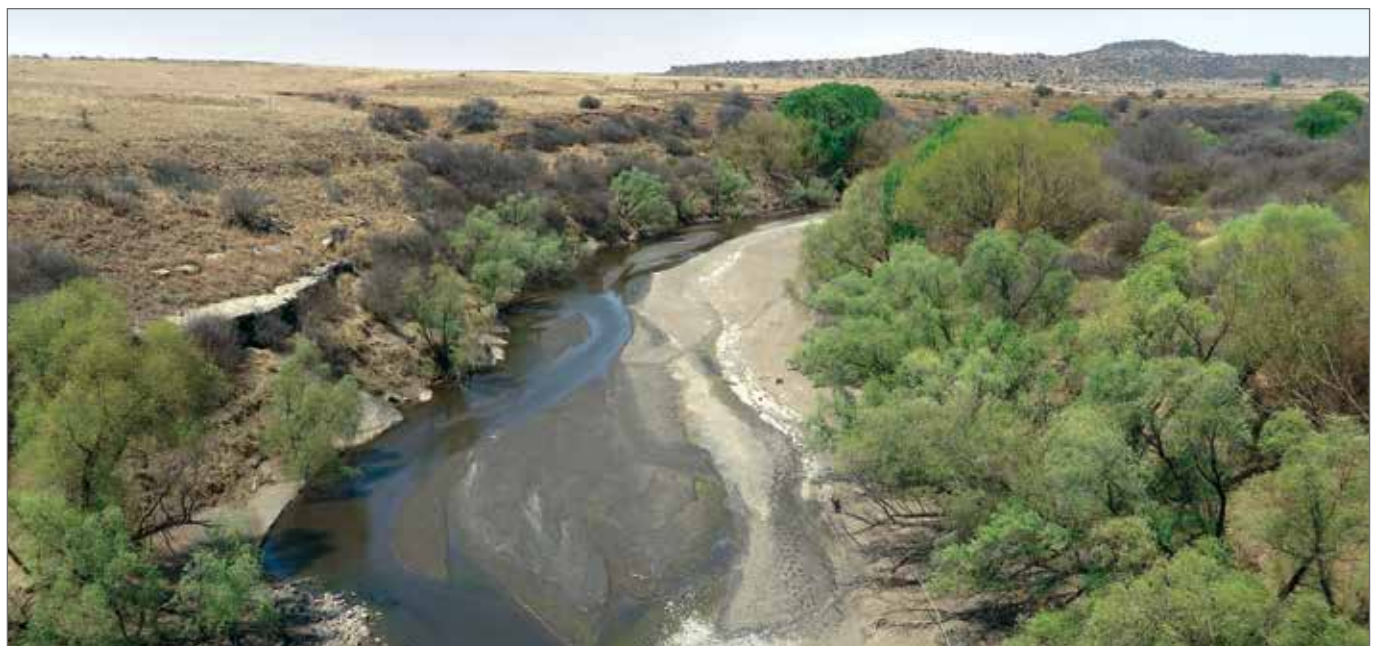
**Figure 11:** An upstream view from the current bridge; notice the remains of the railway bench for the temporary deviation directly to the left of the river (Photo Johannes Haarhoff 2013)

been inaccurate, because even the standard step method, if used, would have been performed manually using slide rules, and the nearest control point, dicey at that, is evidently the confluence of the Orange River, a considerable distance downstream. Figure 11, taken October 2014, tends to confirm that local hydrography could be an issue in computing the flood WSEL, and also supports the contention that debris such as trees would likely have been a significant factor.
