The effect of vibratory pile driving on the original gravity structure quay wall at Ben Schoeman Dock Berth 603, Port of Cape Town

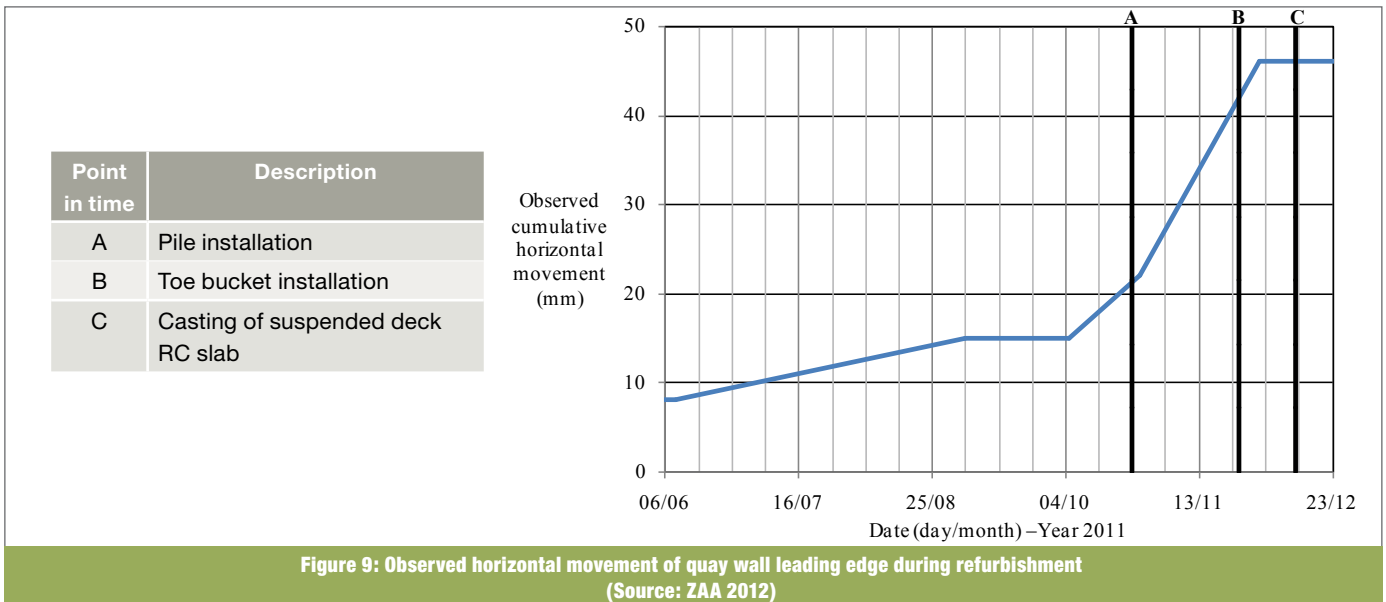
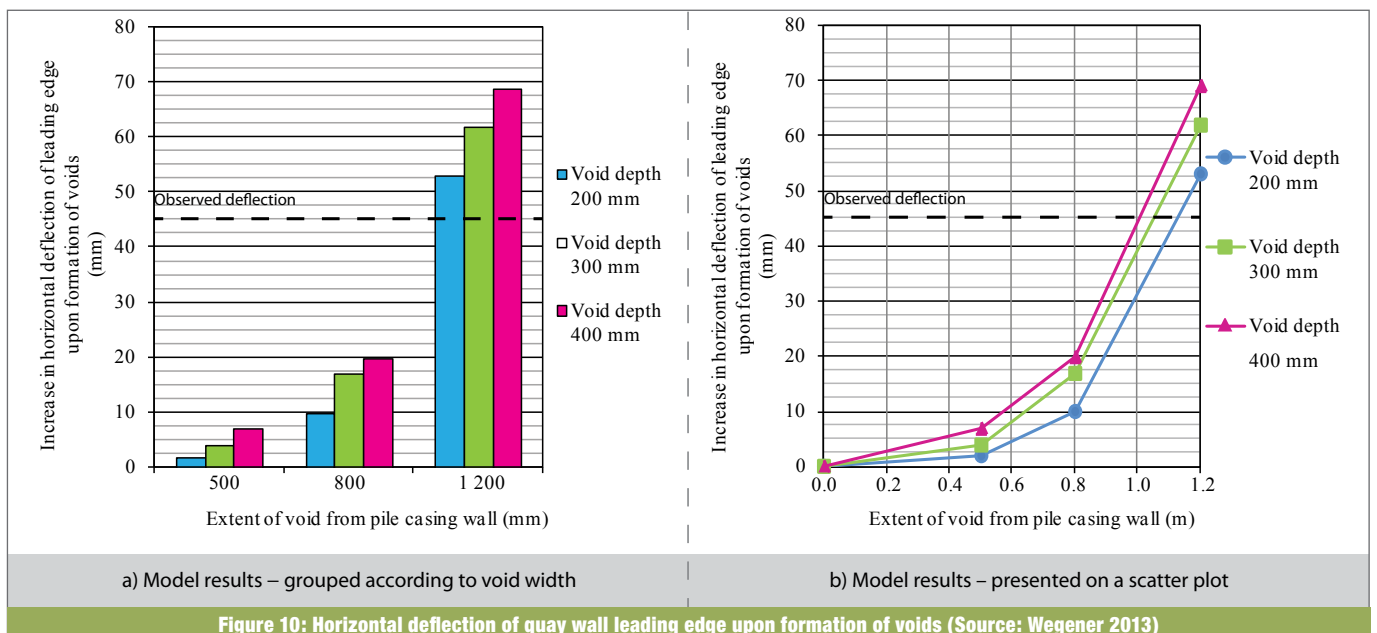
The model analysis was not time-dependent and the results shown in Figure 10 represent the instantaneous cumulative increase in horizontal deflection of the quay wall as a result of void formation. The model results are comparable to the total cumulative deflection shown in Figure 9 (45 mm).

The cumulative horizontal deflection (Figure 9) of the Site quay wall leading edge observed during refurbishment was compared to the lateral deflections indicated by the numerical model output (Figure 10). It must be noted that the point of zero cumulative deflection was considered the position of the leading edge at the start of refurbishment, and that once the suspended deck was connected to the original wall, deflections ceased.

The model analysis was not time-dependent and the results shown in Figure 10 represent the instantaneous cumulative increase in horizontal deflection of the quay wall as a result of void formation. The model results are comparable to the total cumulative deflection shown in Figure 9 (45 mm).

Figure 10(b) shows that the void size corresponding to the observed deflection is less than that of the observed void sizes below the quay wall. However, this result was expected – a plane strain model (which is a conservative representation of the quay foundation conditions) was assumed. Hence, if the measured wall movements were to match the results given by the numerical model, it is likely the void size would be larger in reality than that modelled in the 2D analysis (ZAA 2011a). Comparison of the achieved deflection values to the surveyed data show that the two sets of results do not differ by an order of magnitude. Therefore, the model results were considered sufficiently accurate to warrant further assessment.

In assessing the safety of the quay wall, a cumulative horizontal deflection of 50 mm was considered the serviceability limit state (ZAA 2012). With this borne in mind, Figure 10 shows that the quay wall would have been deemed to fail due to excessive deformation before reaching a condition of collapse. Model results showed that the horizontal deflection corresponding to the largest modelled void was 69 mm – exceeding the specified deflection limit by 40%. However, the quay wall global FOS corresponding to the same void size is greater than 1.0.
